TECHNICAL ASSISTANCE TEAM FOR EMERGENCY RESPONSE REMOVAL AND PREVENTION
EPA CONTRACT 68-01-7367

September 30, 1990

TAT-05-G2-02239

Re: Albion-Sheridan Township Landfill, Albion, Michigan
TDD# 5-9006-05

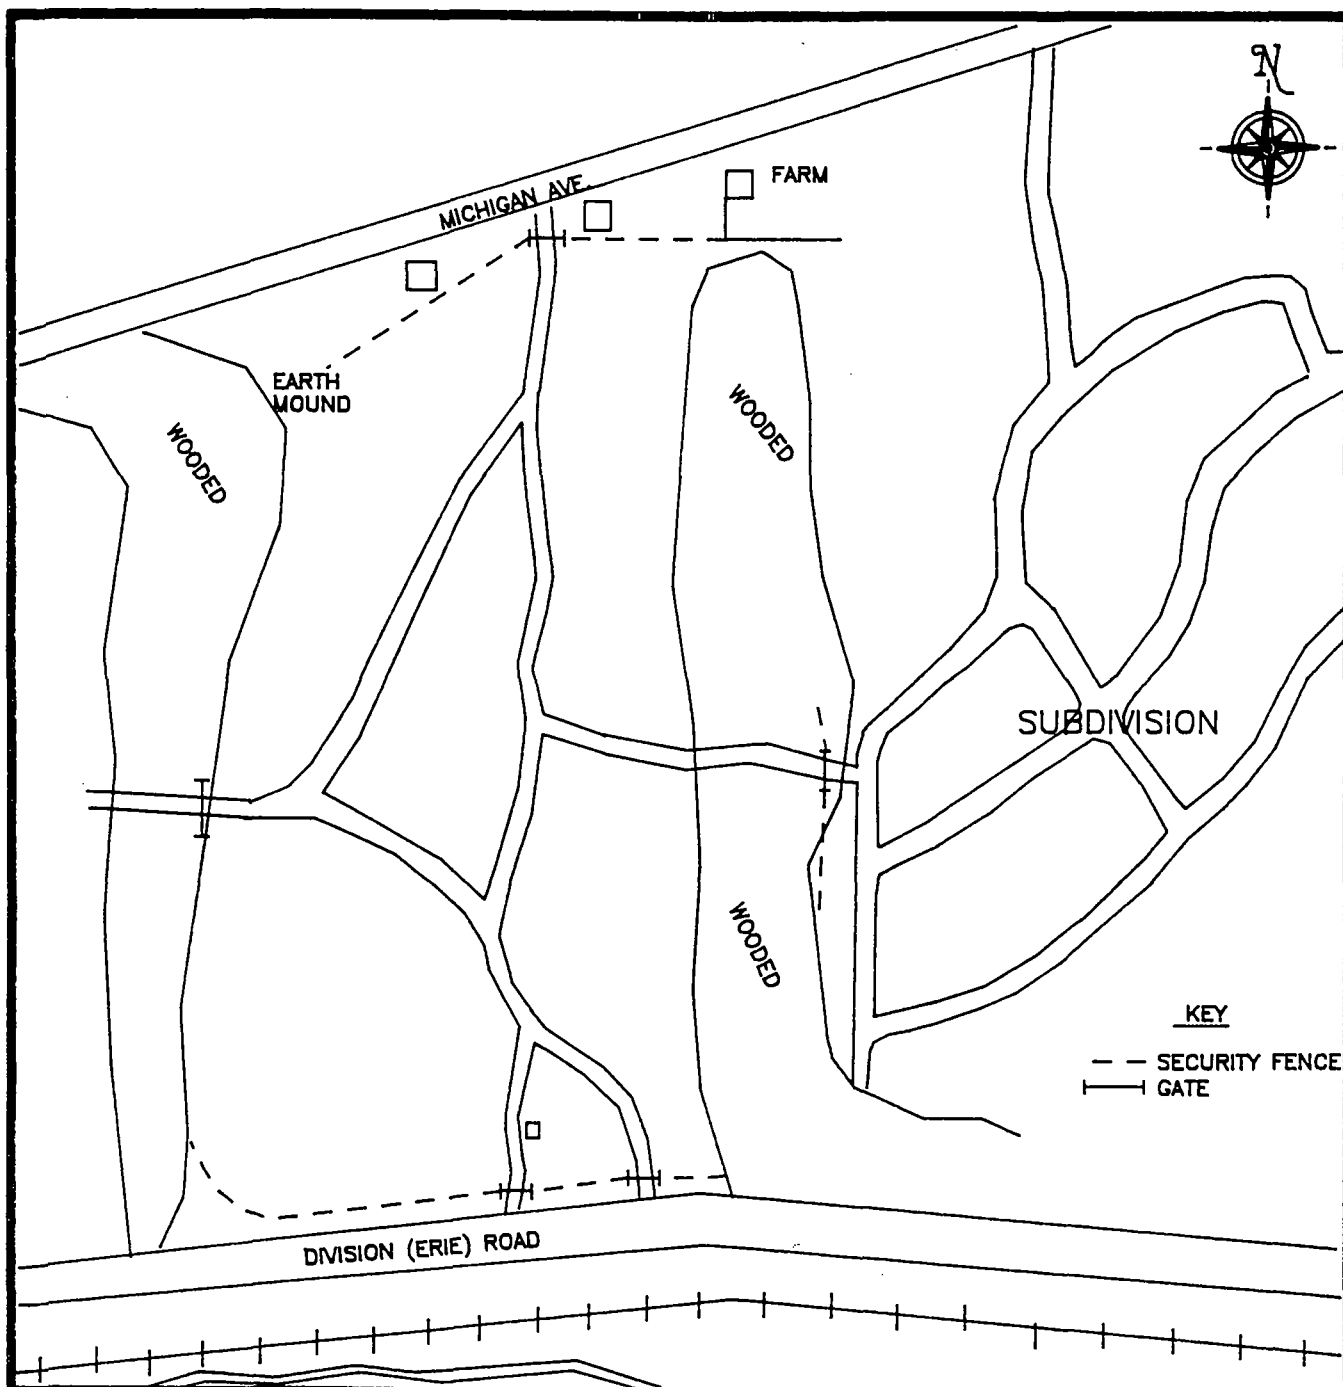
FIGURE 3
 PROPOSED FENCE/GATE LOCATIONS
 SCENARIO 1
 ALBION-SHERIDAN TWP. LANDFILL
 ALBION, MICHIGAN
 NOT TO SCALE

- o sampling, overpacking, removal, and disposal of surface drums and small containers
- o removal of empty surface containers
- o emptying tank contents, if any, and cleaning the tanks.
- o installation of appropriate fencing to restrict vehicle access, as outlined in Scenario 1 (Figure 3), and posting appropriate warning signs around the site perimeter.

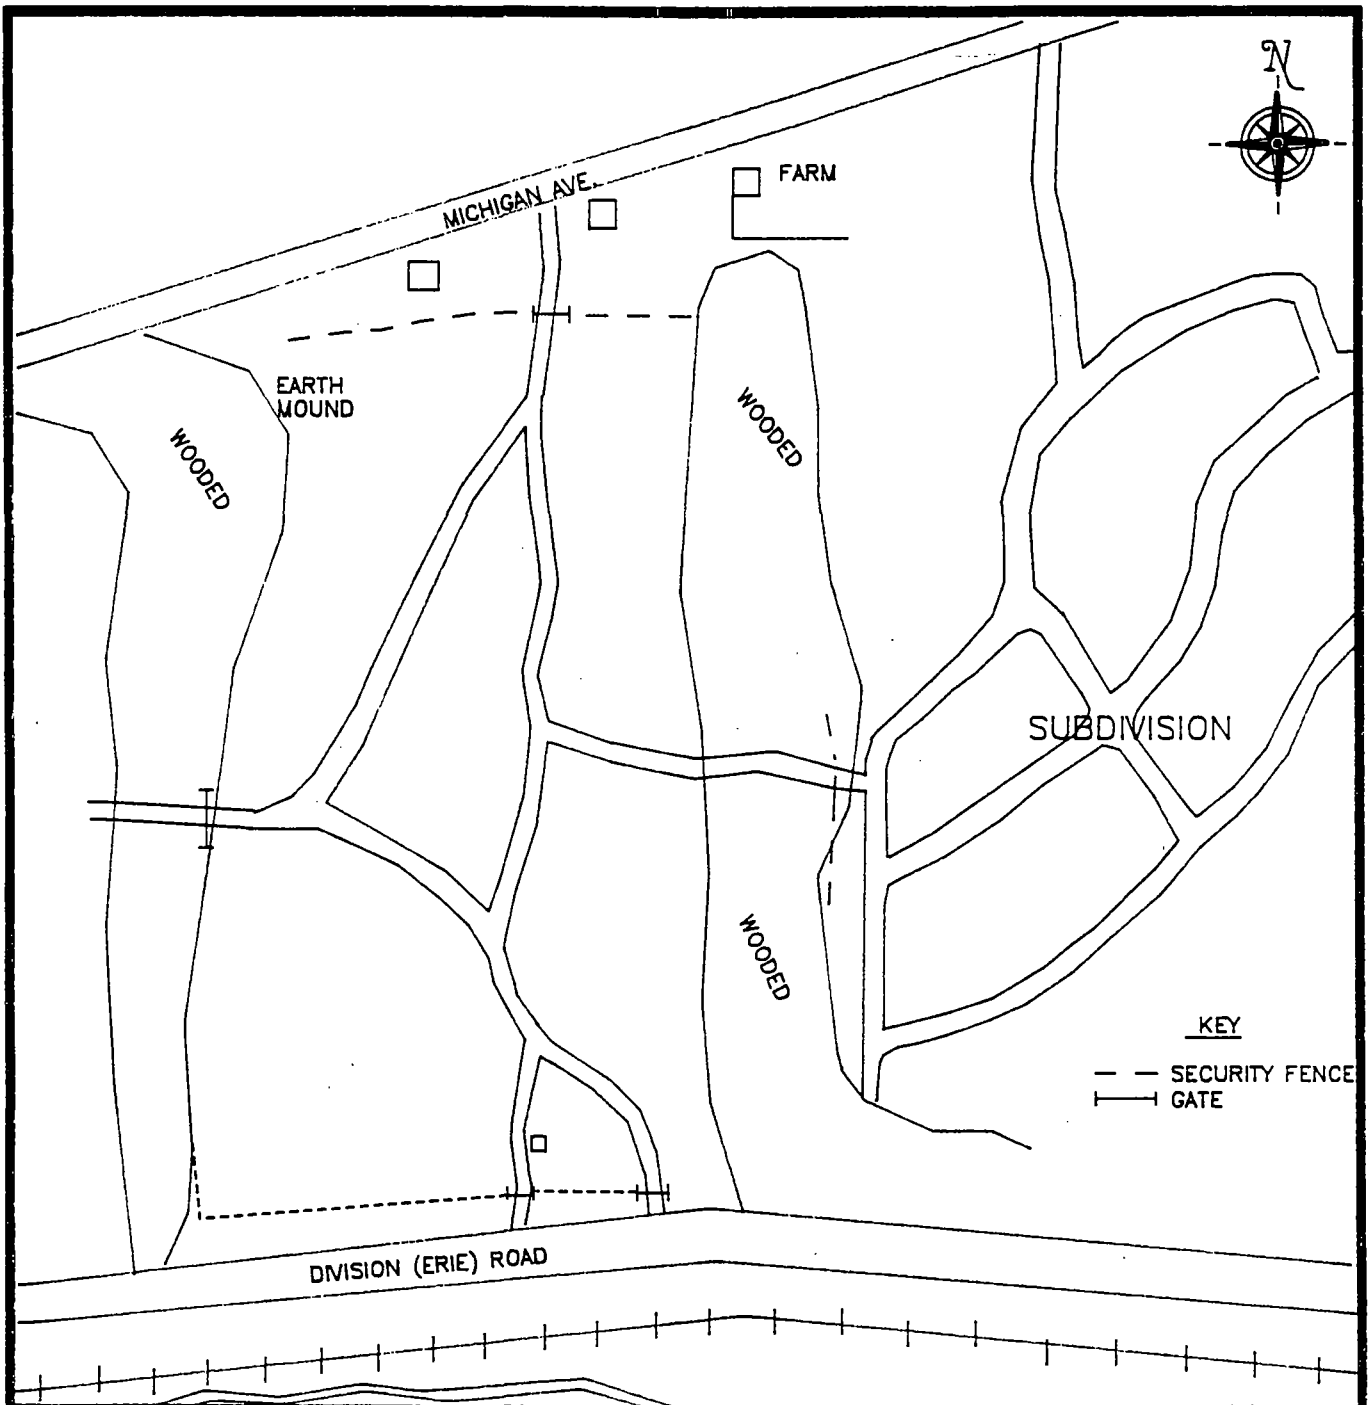
FIGURE 4
 FENCING/GATE LOCATIONS ERECTED BY
 PRP SUBCONTRACTORS - 6/90
 ALBION-SHERIDAN TWP. LANDFILL
 ALBION, MICHIGAN
 NOT TO SCALE

- o building a staging pad;
- o sampling, overpacking, and staging of material-containing drums and containers;
- o staging of empty containers found in the main drum area;
- o inspecting the three tanks, pumping out and drumming the contents, cleaning the two 500-gallon tanks, and cutting a large hole in the 8,000-gallon tank; and
- o removing the old south gate and erecting fencing and gates at the locations as illustrated in Figure 4.

During installation of the fencing along the southern boundary of the site, the owner of the southern portion of the property informed the TAT and GLES that he was not aware of any plans to install a fence and that he did not want it on his property. At this time, it was discovered that access to this portion of the landfill was not obtained. The old south gate was then replaced with the new gate, and the remainder of the fencing was not completed until permission was later obtained from the owner. The owner agreed that a fence could be installed if the fence was placed on the legal property line. GLES subcontracted a surveyor to determine this location and the installation of the fence along the southern boundary was completed on July 11, 1990.

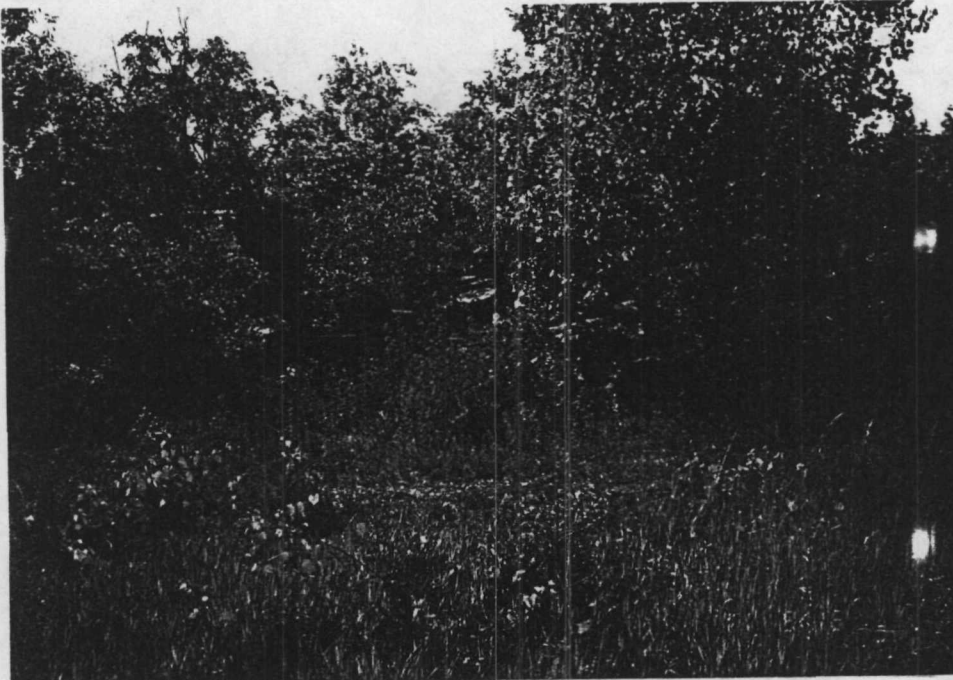
Site: AST LANDFILL
 Photo No: 01 Date: 6-11-90
 Direction: EAST
 Camera: OLYMPUS INFINITY 35mm
 Photographer: A. BENDA *AB*
 Subject: SURFACE DRUMS IN MAIN DRUM
 AREA.

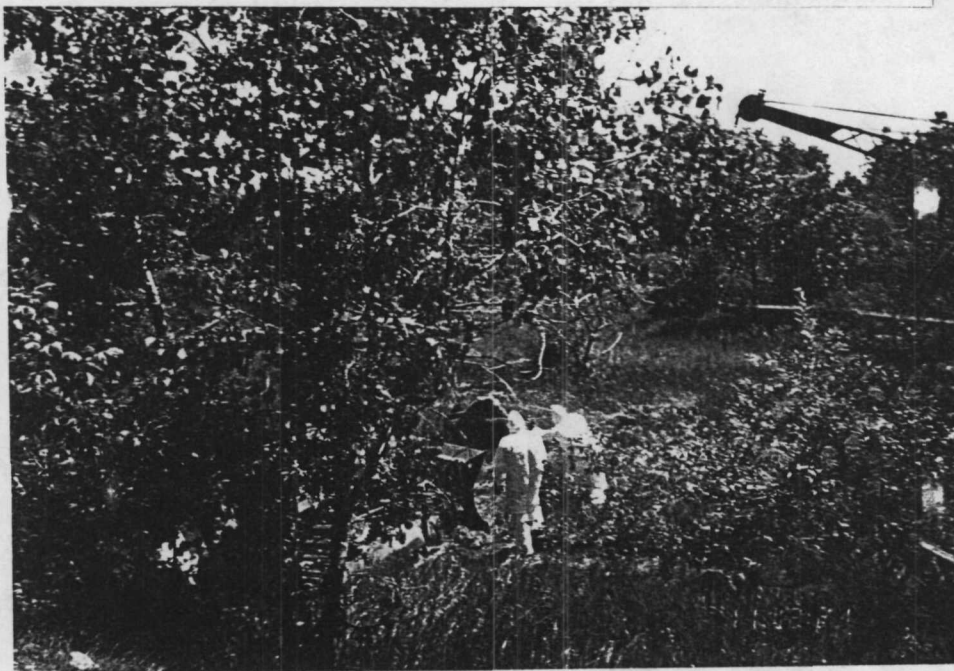
Sampling and overpacking activities during the surface-material removal were somewhat delayed due to the existence of an active hive of bees in the main drum area. Attempts to rid the area of the bees were unsuccessful and an apiarist was called in to remove them.

Site: AST LANDFILL
 Photo No: 02 Date: 6-11-90
 Direction: EAST-NORTHEAST
 Camera: OLYMPUS INFINITY 35mm
 Photographer: A. BENDA *AB*
 Subject: ATTEMPTS TO RID AREA OF
 BEES.

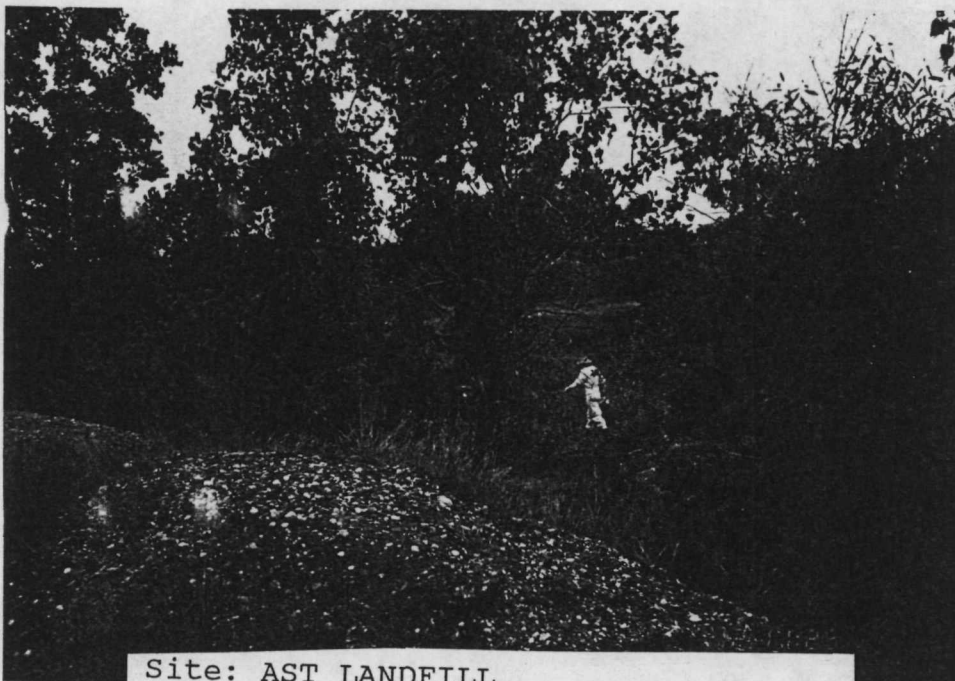
Site: AST LANDFILL
 Photo No: 03 Date: 6-12-90
 Direction: EAST
 Camera: OLYMPUS INFINITY 35mm
 Photographer: A. BENDA *AB*
 Subject: APIARY SETTING UP APPARATUS
 TO RID AREA OF BEES.

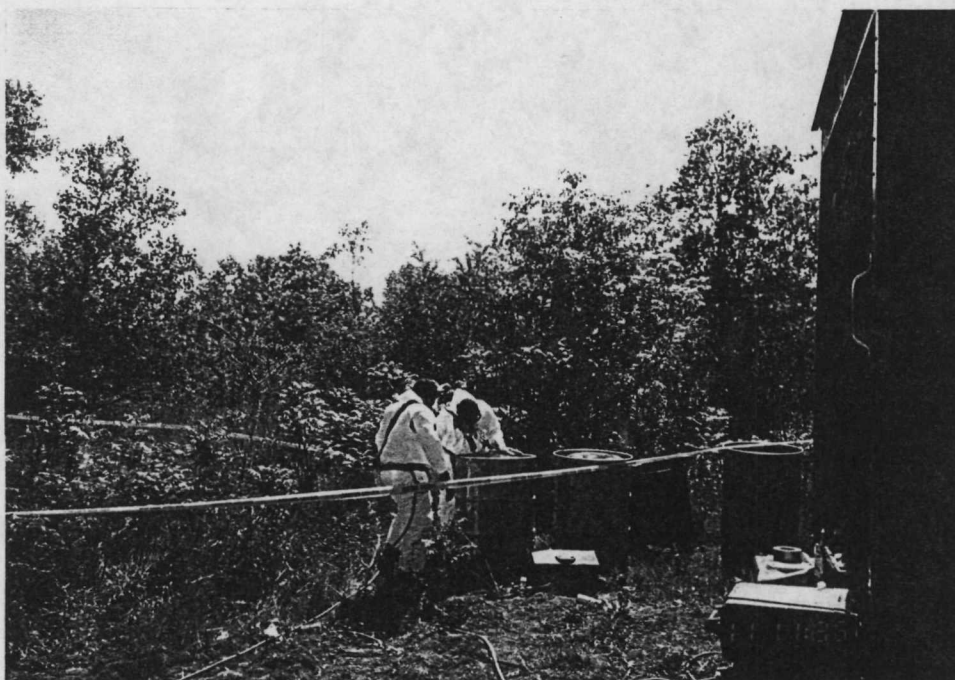
Site: AST LANDFILL
 Photo No: 04 Date: 6-11-90
 Direction: EAST
 Camera: OLYMPUS INFINITY 35mm
 Photographer: A. BENDA *AB*
 Subject: OVERPACKING OF DRUMS IN
 MAIN DRUM AREA.

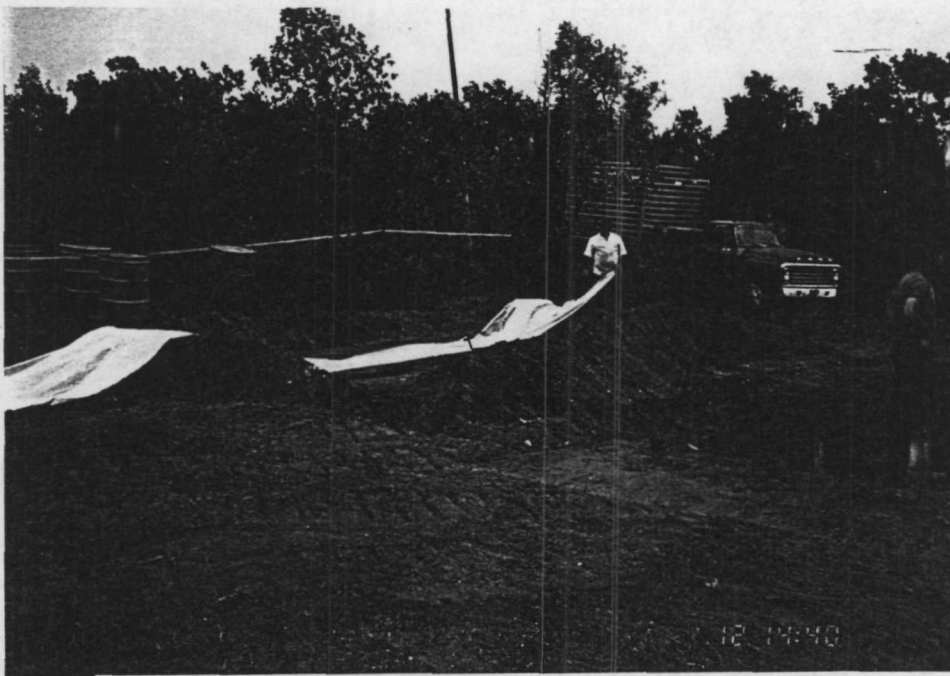
Site: AST LANDFILL
 Photo No: 05 Date: 6-12-90
 Direction: NORTHEAST
 Camera: OLYMPUS INFINITY 35mm
 Photographer: A. BENDA *AB*
 Subject: STAGING PAD CONSTRUCTION.

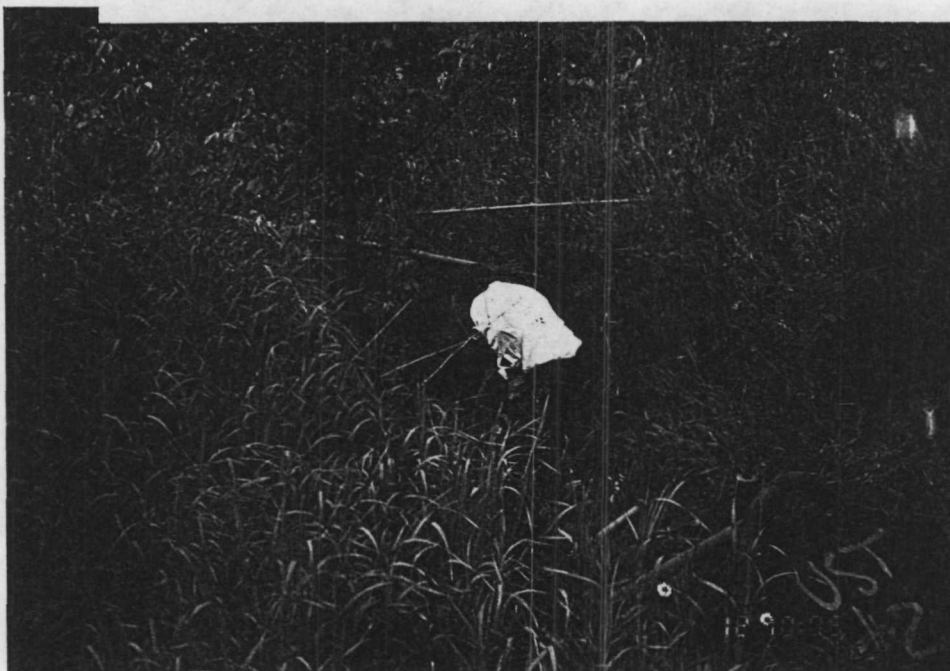
The investigation of the tanks revealed that UST #1 was empty and the UST #2 contained approximately five gallons of liquid presumed to be gasoline. The above ground 8,000-gallon tank was cut open and found to be completely empty. Air monitoring readings on this tank using a tritector showed background readings for % oxygen and % LEL. Identification tags were found on each of the tanks and read as follows:

Site: AST LANDFILL
 Photo No: 06 Date: 6-12-90
 Direction: SOUTHWEST
 Camera: OLYMPUS INFINITY 35mm
 Photographer: A. BENDA *AB*
 Subject: CUTTING OF UST #1 TO CHECK
 CONTENTS. TANK WAS EMPTY.

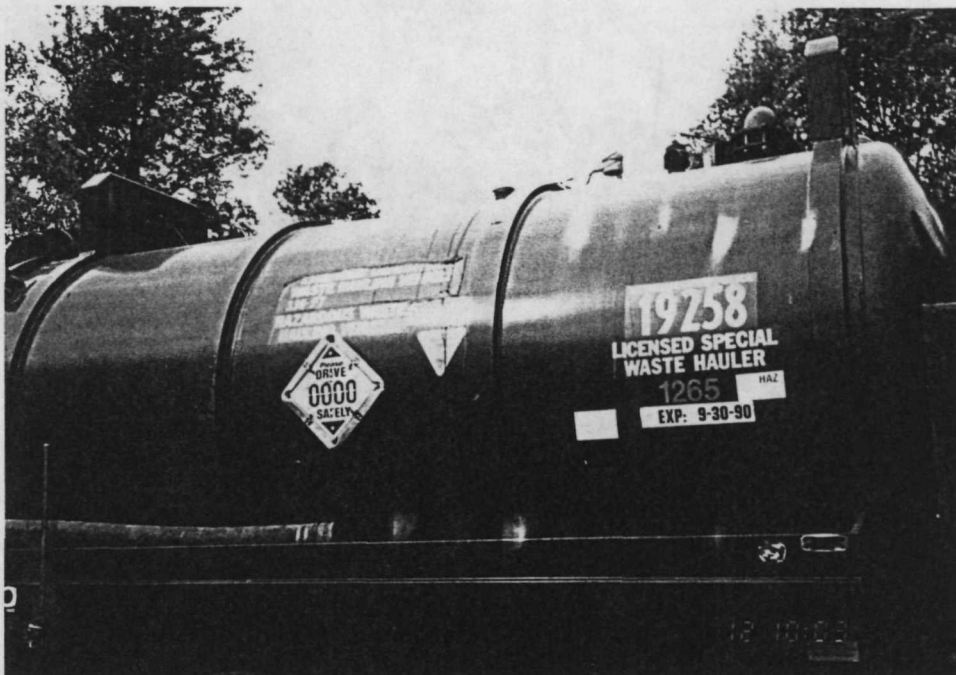
Site: AST LANDFILL
 Photo No: 07 Date: 6-12-90
 Direction: WEST-SOUTHWEST
 Camera: OLYMPUS INFINITY 35mm
 Photographer: A. BENDA *AB*
 Subject: VAC TRUCK USED TO TRANSFER
 CONTENTS OF UST #2 TO 55 GAL DRUMS.

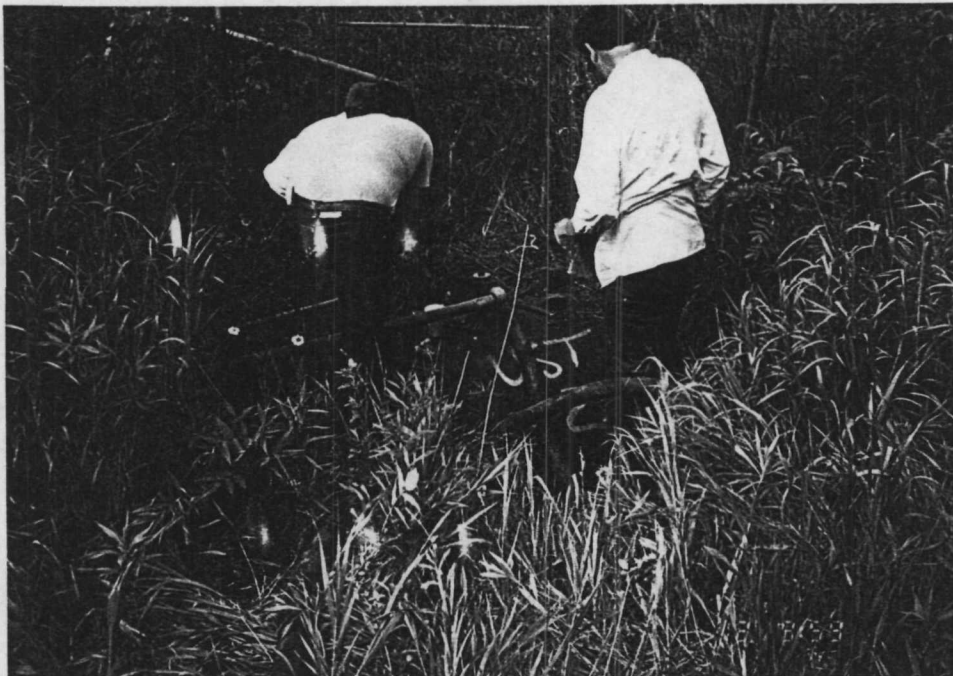
Site: AST LANDFILL
 Photo No: 09 Date: 6-12-90
 Direction: WEST-SOUTHWEST
 Camera: OLYMPUS INFINITY 35mm
 Photographer: A. BENDA *AB*
 Subject: PUMPING CONTENTS OF UST #2.

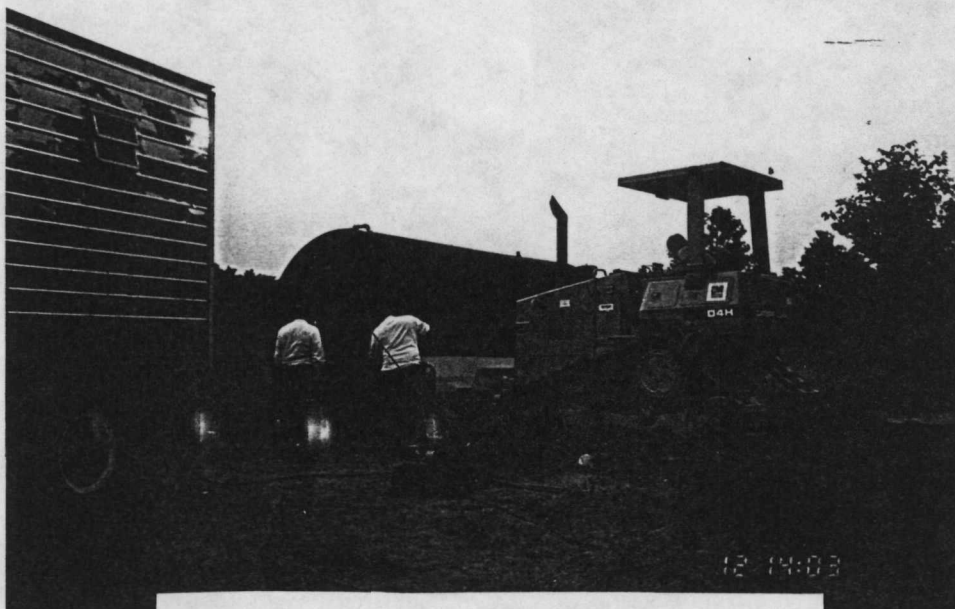
Site: AST LANDFILL
 Photo No: 11 Date: 6-12-90
 Direction: NORTH-NROTHWEST
 Camera: OLYMPUS INFINITY 35mm
 Photographer: A. BENDA *AB*
 Subject: CUTTING OF 8,000 GALLON
 STORAGE TANK.

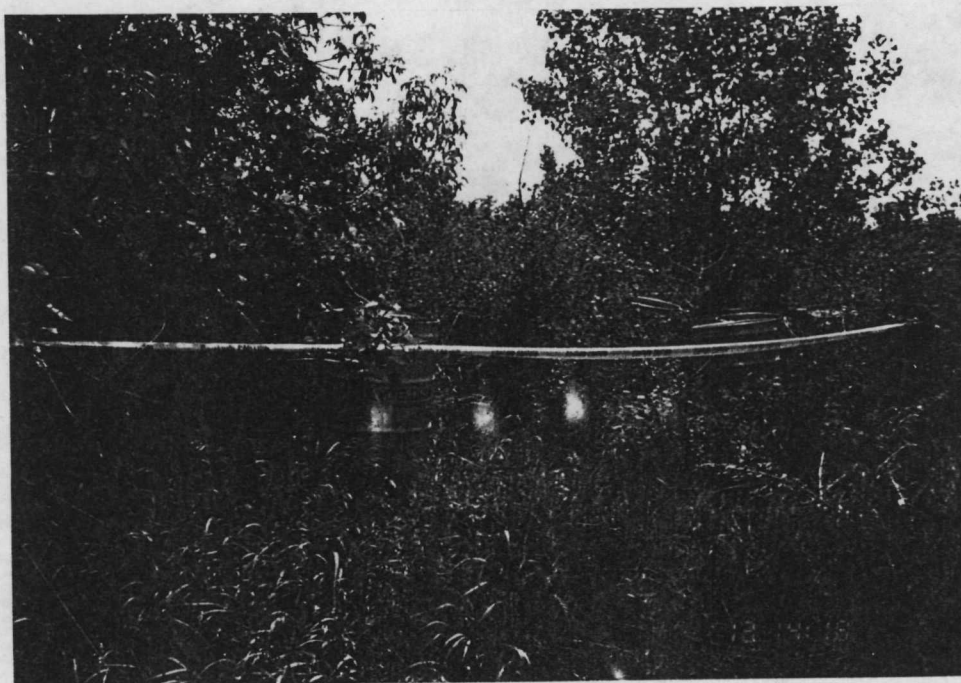
Site: AST LANDFILL
 Photo No: 12 Date: 6/13/90
 Direction: NORTHEAST
 Camera: OLYMPUS INFINITY 35mm
 Photographer: A. BENDA *AB*
 Subject: OVERPACKED DRUMS STAGED IN
 ORIGINAL DRUM AREA.

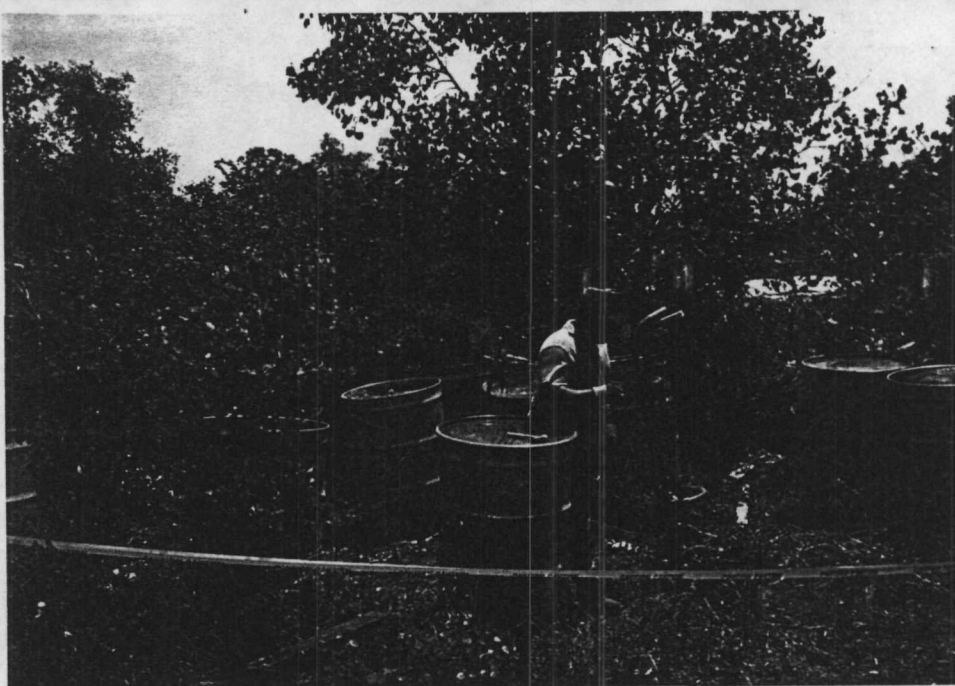
Site: AST LANDFILL
 Photo No: 13 Date: 6/13/90
 Direction: NORTHEAST
 Camera: OLYMPUS INFINITY 35mm
 Photographer: A. BENDA *AB*
 Subject: OVERPACKED DRUMS PRIOR TO
 STAGING. NOTE BLUE PAINT ON GROUND.

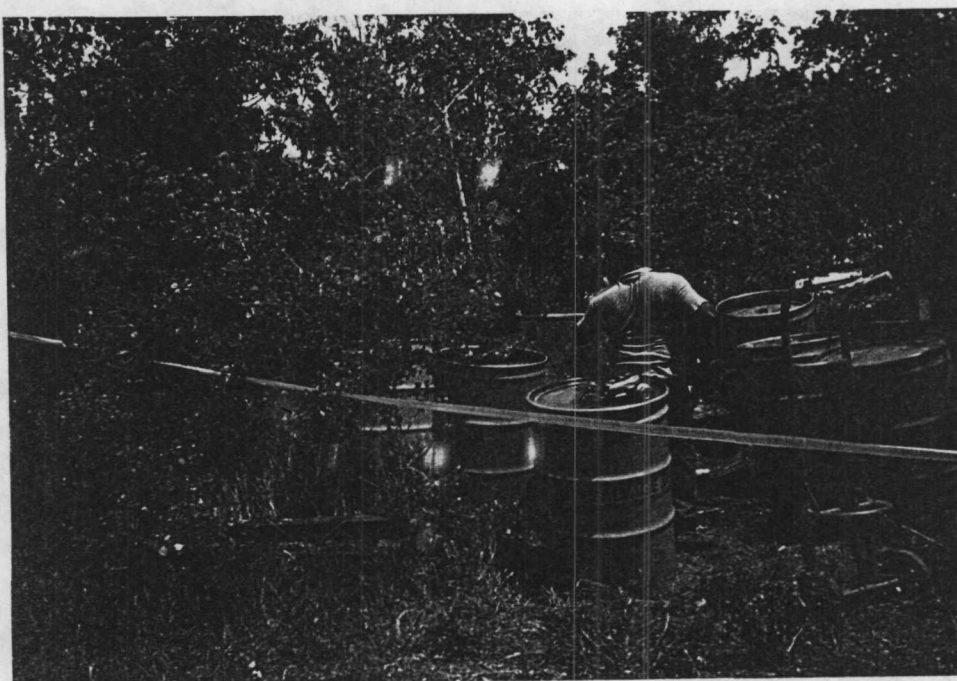
Site: AST LANDFILL
 Photo No: 14 Date: 6/13/90
 Direction: NORTHEAST
 Camera: OLYMPUS INFINITY 35mm
 Photographer: A. BENDA *AB*
 Subject: GREAT LAKES ENV. PERSONNEL
 OVERPACK BLUE PAINT MATERIAL.

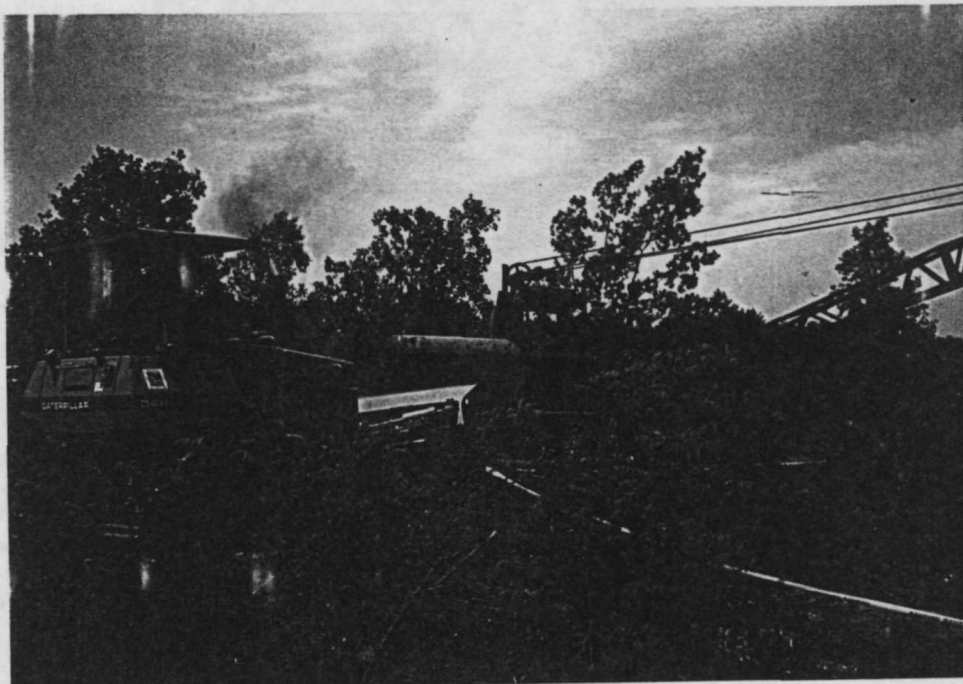
Site: AST LANDFILL
 Photo No: 15 Date: 6/13/90
 Direction: NORTHEAST
 Camera: OLYMPUS INFINITY 35mm
 Photographer: A. BENDA *AB*
 Subject: GREAT LAKES ENV. OPERATOR
 MOVES CRANE W/DOZER FOR STAGING PAD.

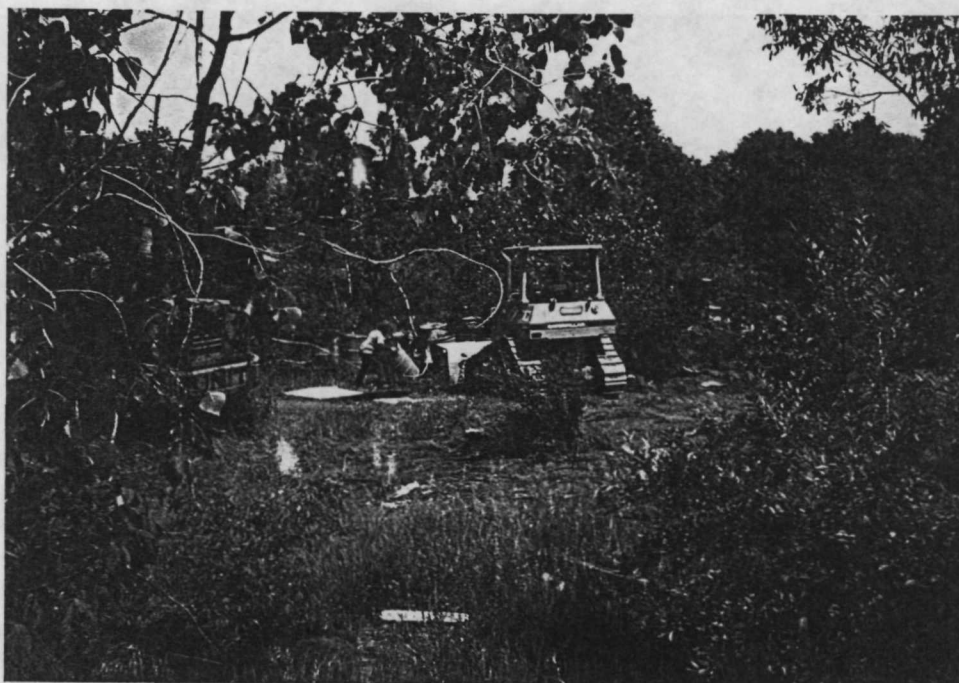
Site: AST LANDFILL
 Photo No: 16 Date: 6/13/90
 Direction: EAST-NORTHEAST
 Camera: OLYMPUS INFINITY 35mm
 Photographer: A. BENDA *AB*
 Subject: MOVEMENT OF OVERPACKED
 DRUMS FROM MAIN AREA TO PAD.

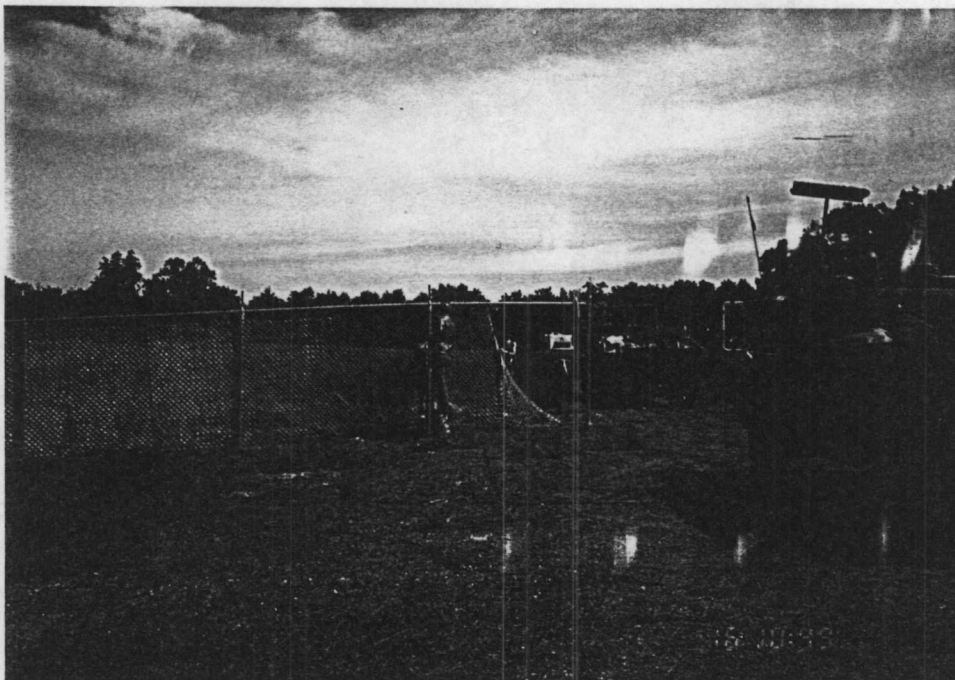
Site: AST LANDFILL
 Photo No: 17 Date: 6/16/90
 Direction: NORTH
 Camera: OLYMPUS INFINITY 35mm
 Photographer: A. BENDA *AB*
 Subject: INSTALLATION OF SECURITY
 FENCING ALONG NORTH EDGE OF SITE.

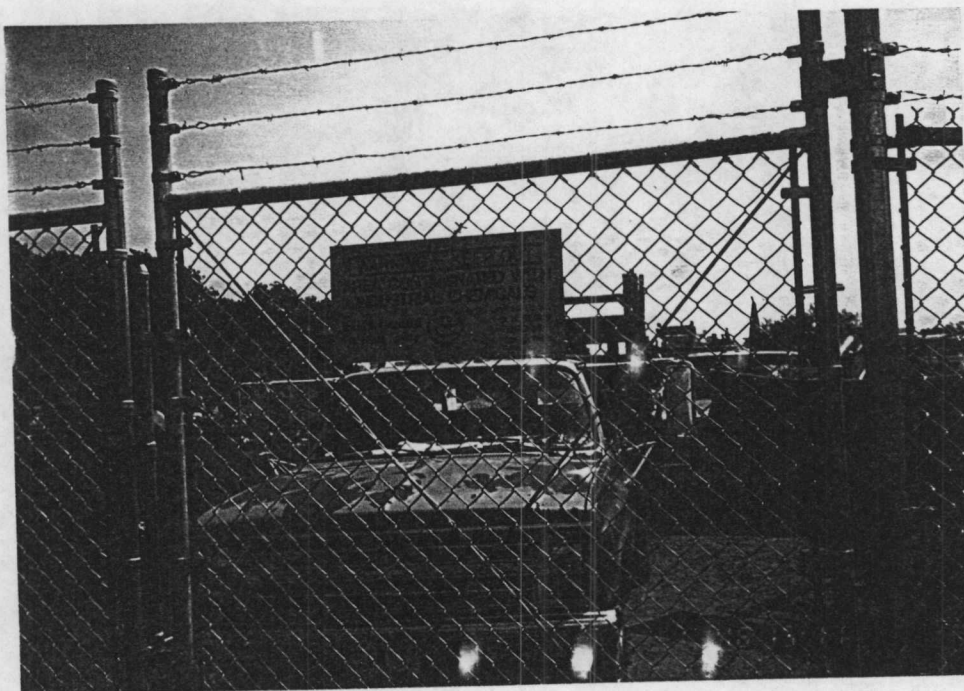
Site: AST LANDFILL
 Photo No: 18 Date: 6/16/90
 Direction: SOUTH
 Camera: OLYMPUS INFINITY 35mm
 Photographer: A. BENDA *AB*
 Subject: SIGNAGE AT NORTH GATE.

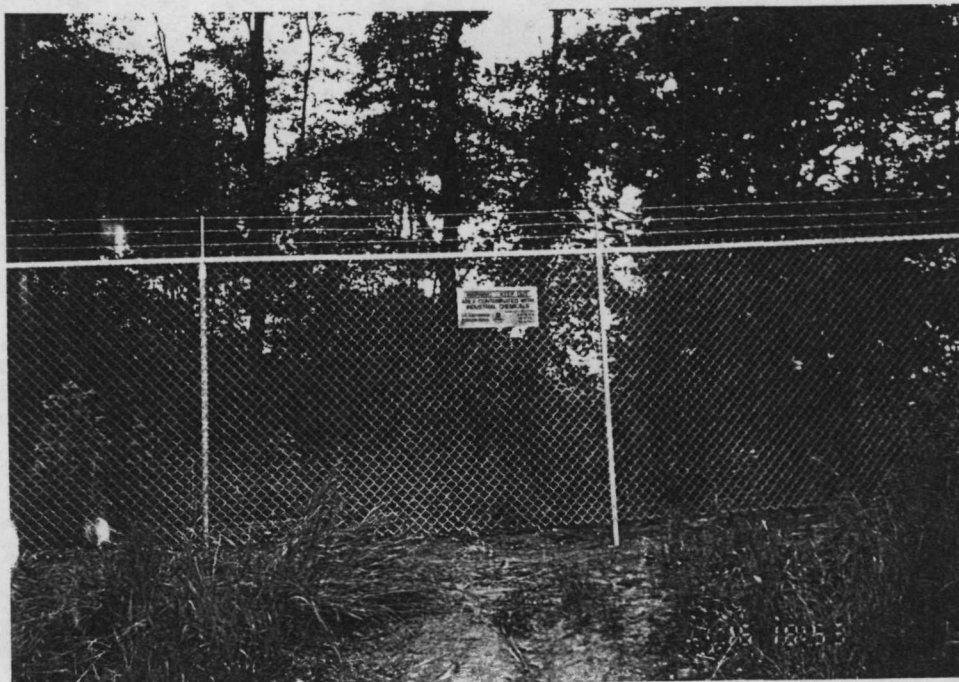
Site: AST LANDFILL
 Photo No: 19 Date: 6/16/90
 Direction: WEST
 Camera: OLYMPUS INFINITY 35mm
 Photographer: A. BENDA *AB*
 Subject: SIGNAGE AND FENCING ALONG
 EASTERN EDGE OF GATE.

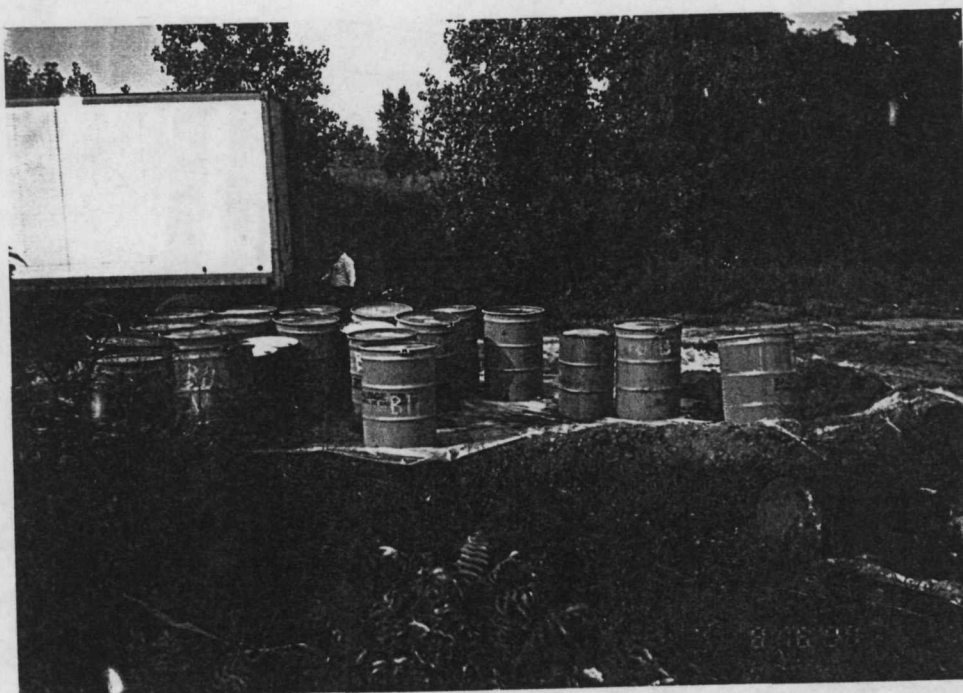
Site: AST LANDFILL
 Photo No: 20 Date: 8/16/90
 Direction: SOUTH-SOUTHWEST
 Camera: OLYMPUS INFINITY 35mm
 Photographer: B. VAN OTTEREN *BVo*
 Subject: OVERPACKED DRUMS AWAITING FINAL DISPOSAL.

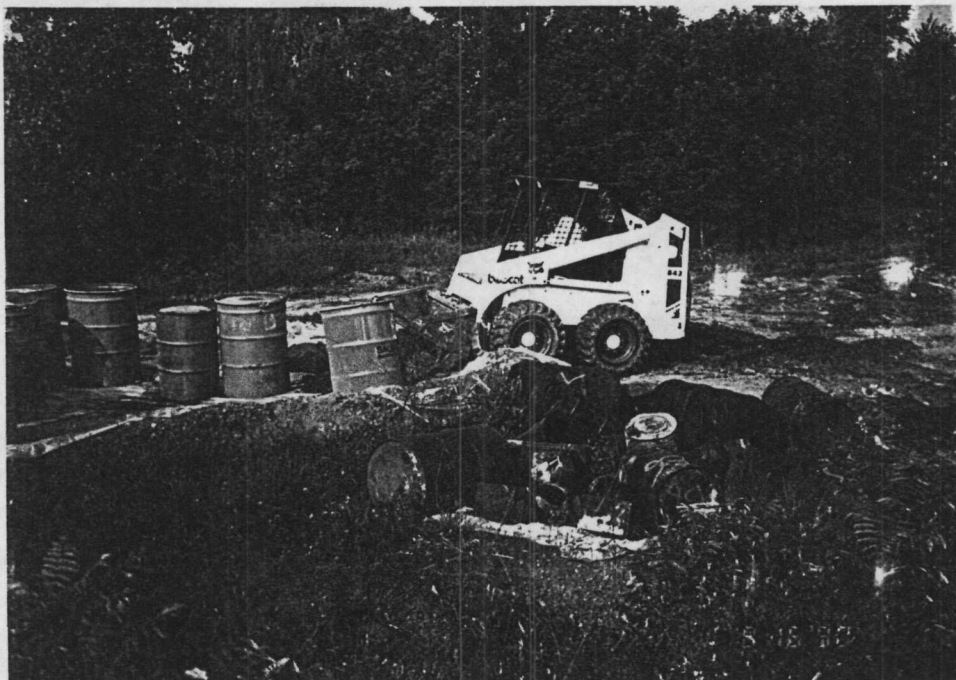
Photo No: 21 Date: 8/16/90

Subject: GLES BOBCAT OPERATOR LOADS OVERPACKED DRUMS FROM STAGING AREA FOR FINAL DISPOSAL.

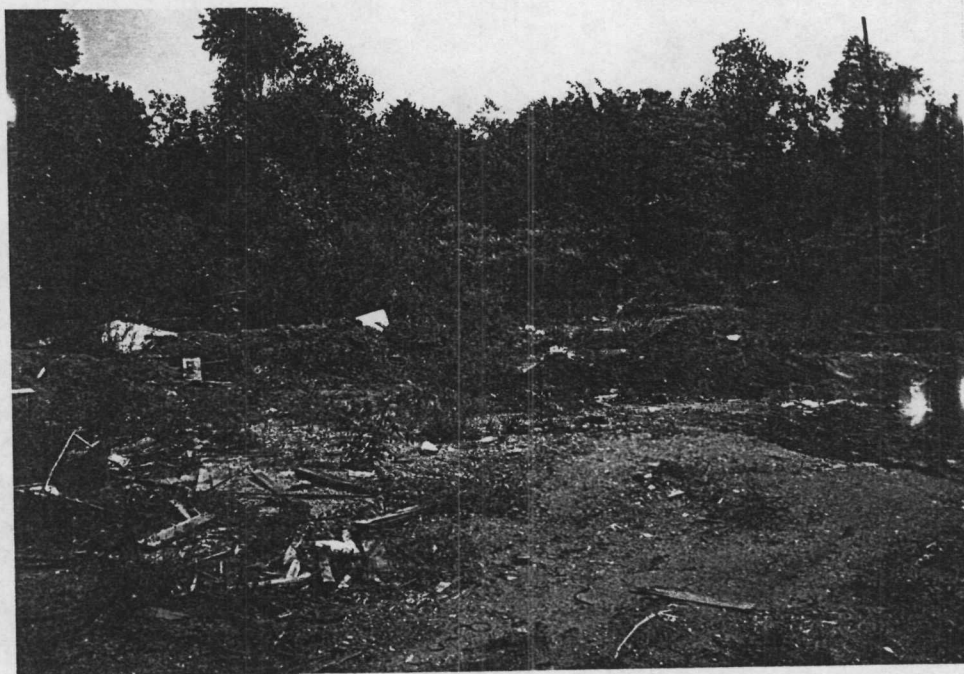
Photo No: 22 Date: 8/16/90

Subject: MAIN DRUM AREA AND STAGING AREA, AFTER DRUMS HAVE BEEN REMOVED.
